**Vehicular Crash Tests Of  
Unanchored Safety-Shaped  
Precast Concrete Median Barriers  
With Pinned End Connections**

**FINAL REPORT**

**CA-DOT-TL-6824-1-76-52**

**AUGUST 1976**

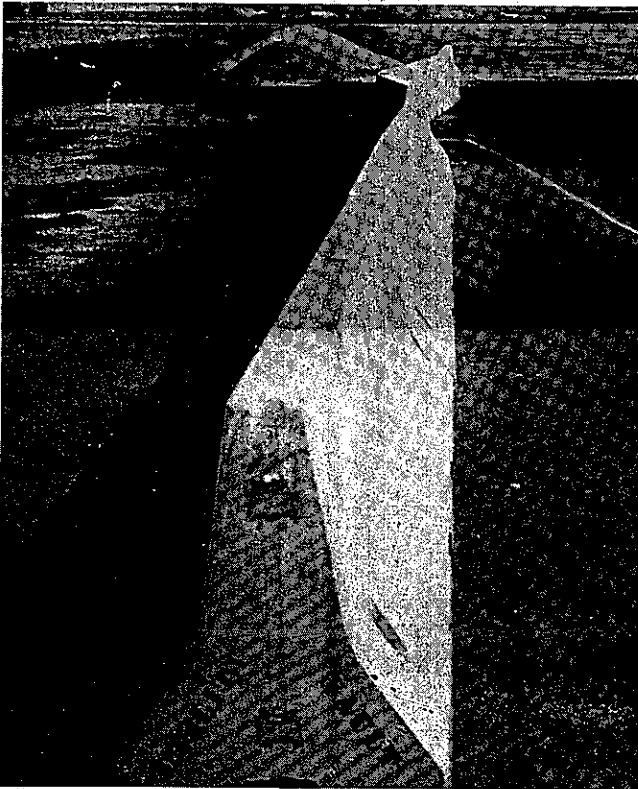
Figure 8, Barrier Movement

Barrier Movement and Damage - Maximum lateral barrier displacement of 6 1/4 inches occurred at the first pinned barrier joint downstream from the point of impact, Figures 7 and 8. Five of the twelve barrier segments translated laterally during impact.

Barrier Movement and Damage - Six barrier segments were laterally displaced during impact, Figures 7 and 8. Maximum lateral displacement of 22 1/4 inches occurred at the upstream end of the first impacted barrier segment, joint 5. The downstream end of this segment moved laterally 16 1/4 inches. All of the pinned joints of the barrier remained connected during impact. During impact, the initially impacted barrier segment leaned back about 16° away from its vertical axis.

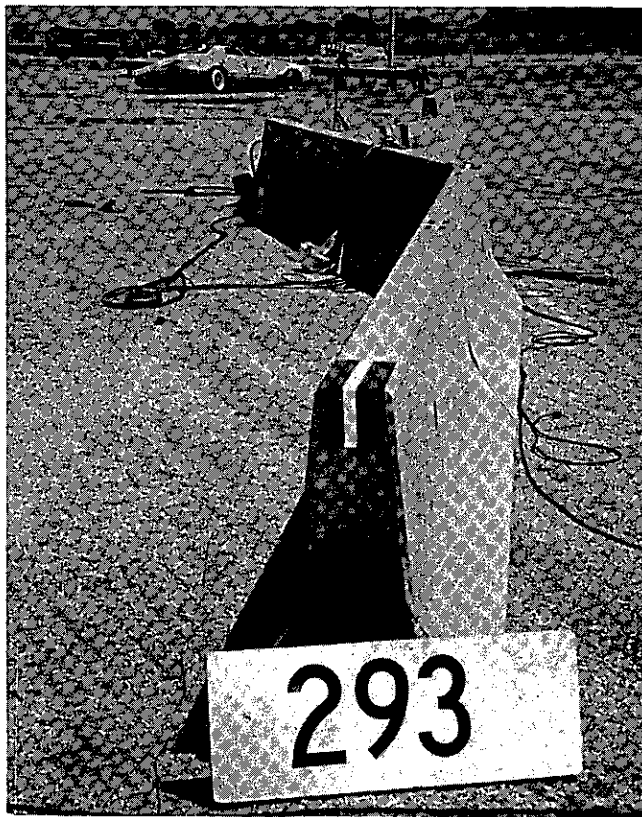
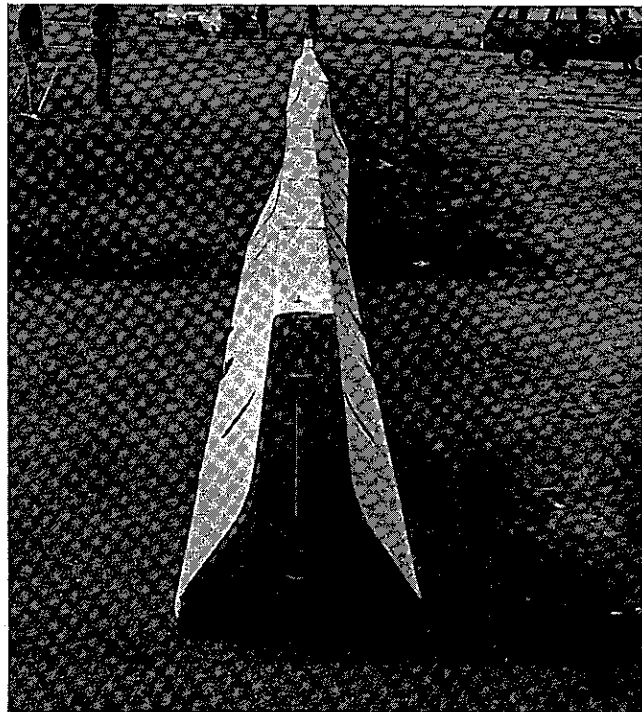
Figure 9, Barrier Movement

Barrier Movement and Damage - Four of five barrier segments were laterally displaced during impact, Figures 7 and 9. Only the last barrier segment remained on line. Maximum lateral displacement of  $11 \frac{1}{8}$  inches occurred at the upstream joint of the first impacted barrier segment, joint 2, Figure 7. The second and third joints failed to restrain the lateral and rotational movement of the impacted barrier segment, which tipped over on its side. The steel hinge bars and steel connecting rods were severely bent, Figure 16. The steel rod at joint 1 was also bent during impact, Figure 17.

Barrier Movement and Damage - Four of six barrier segments were laterally displaced during impact, Figures 7 and 9. Maximum lateral displacement of 5 1/2 inches occurred at the first barrier joint downstream from impact.

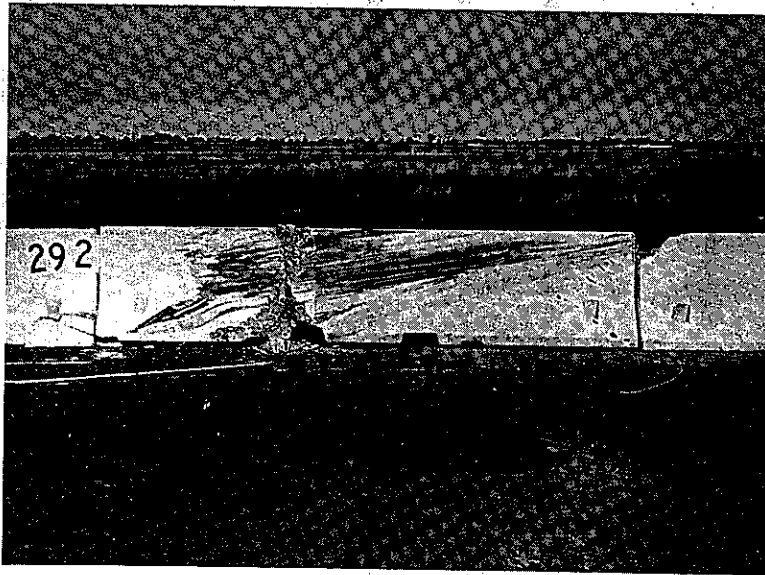
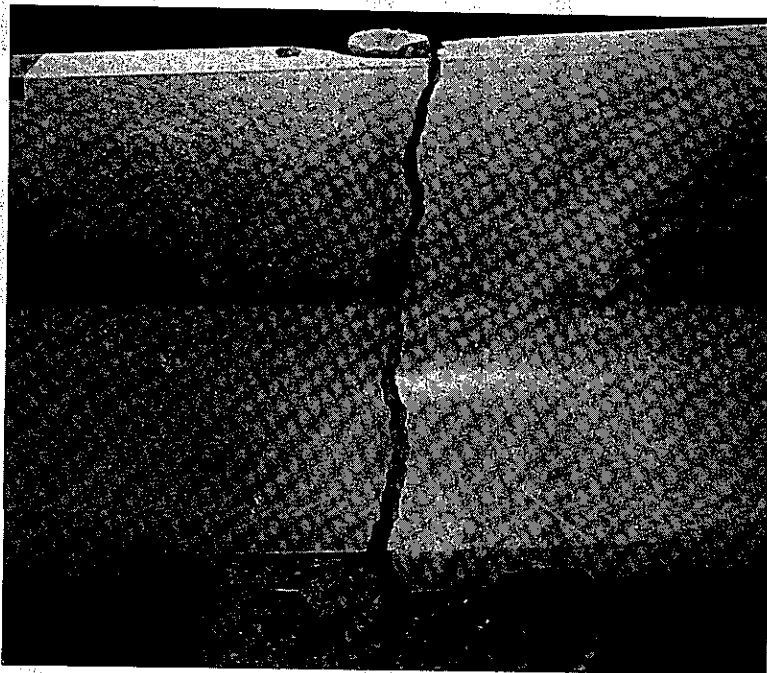
Figure 10, Barrier Damage, Test 292

The test barrier suffered considerable damage. At the point of impact the barrier failed in bending. The tension side of the barrier was completely fractured, while the front face of the barrier showed signs of a severe compression failure, Figure 10.

Impact Side of  
Barrier;

Compression Failure  
at Point of Impact

Back Side of  
Barrier

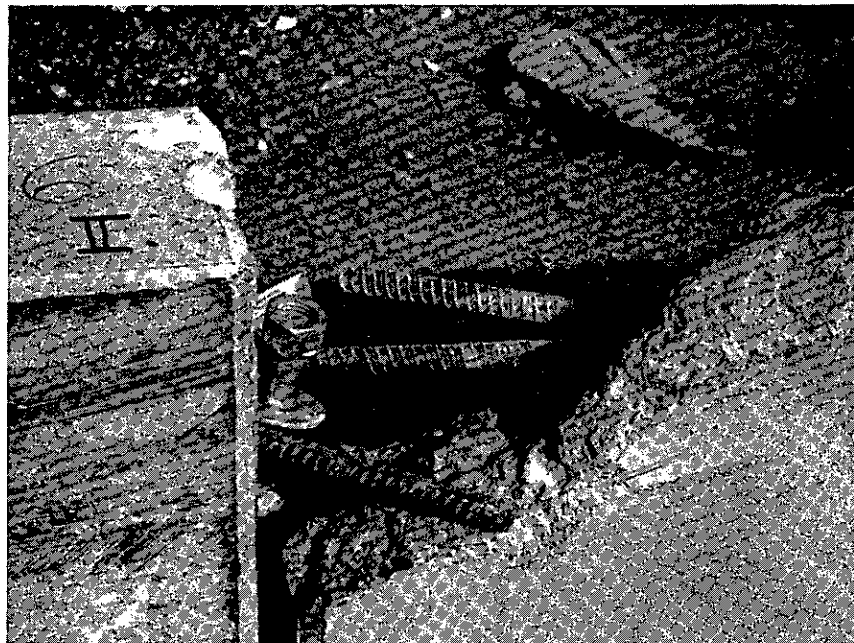
The top reinforcing steel hinge bar at the first downstream barrier joint from impact, joint 6, was pulled out of the concrete, Figure 11. A crack in a barrier segment at joint 7 also indicated a probable bond failure of a top reinforcing hinge bar, Figure 12.

Figure 11, Top Hinge Rebar Pull-Out Failure (view of impact side of barrier), First Joint Downstream from Impact, Test 292

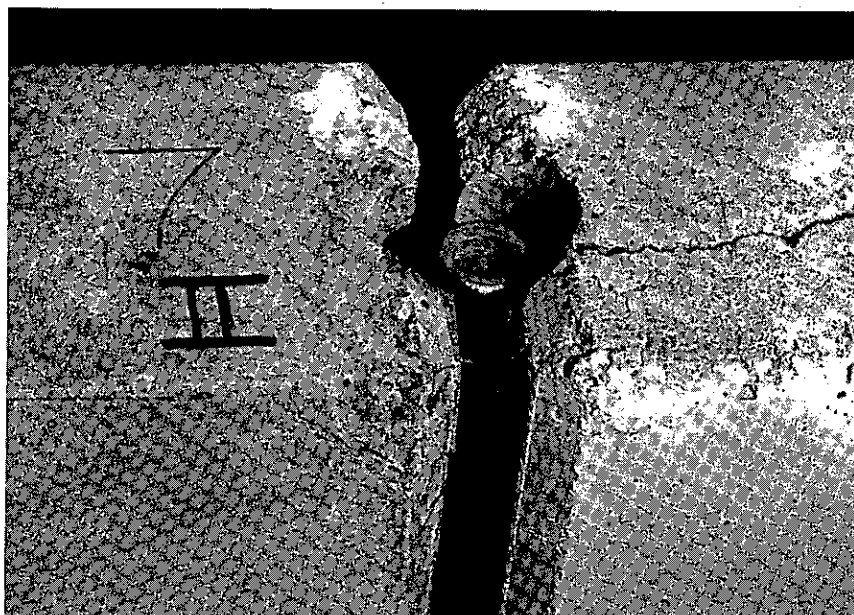
Figure 12, Probable Bond Failure of Top Hinge Rebar (view of impact side of barrier), Second Joint Downstream from Impact, Test 292

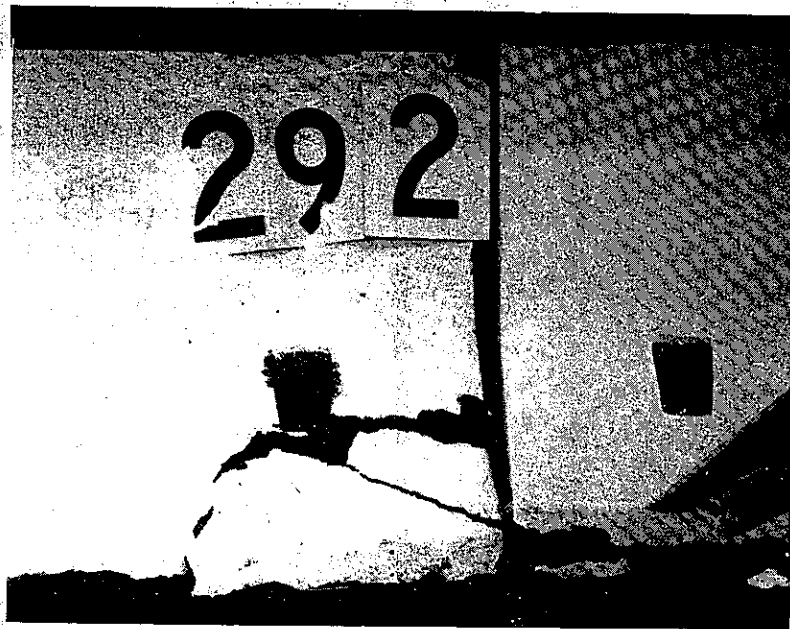
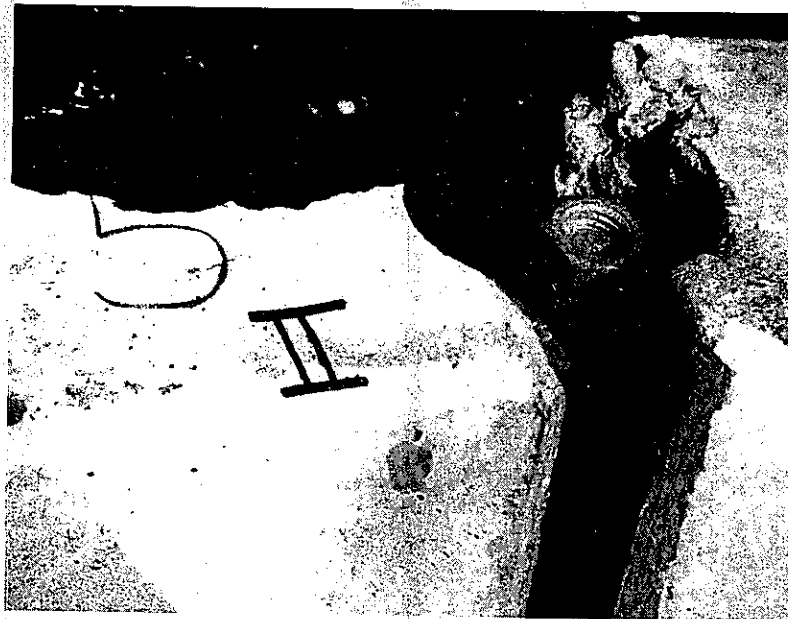
In addition to the fractured concrete at the locations of impact and pull-out of two top hinge bars, concrete spalled at joints 4, 5, and 6, Figures 13 through 15. Several large spalled pieces of concrete, 10 inches maximum dimension, were thrown about 25 feet in back of the barrier during impact. The steel rods connecting joints 4 through 7 were bent during impact.

Figure 13, Concrete Spalling at Joint 5  
(first joint upstream from impact),  
Test 292

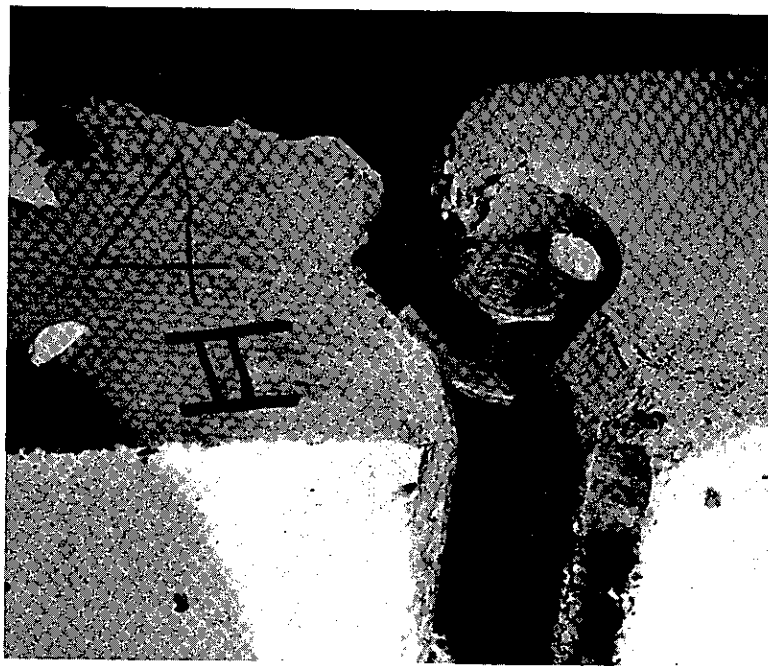
Figure 14, Concrete Spalling at Joint 4 (second joint upstream from impact), Test 292

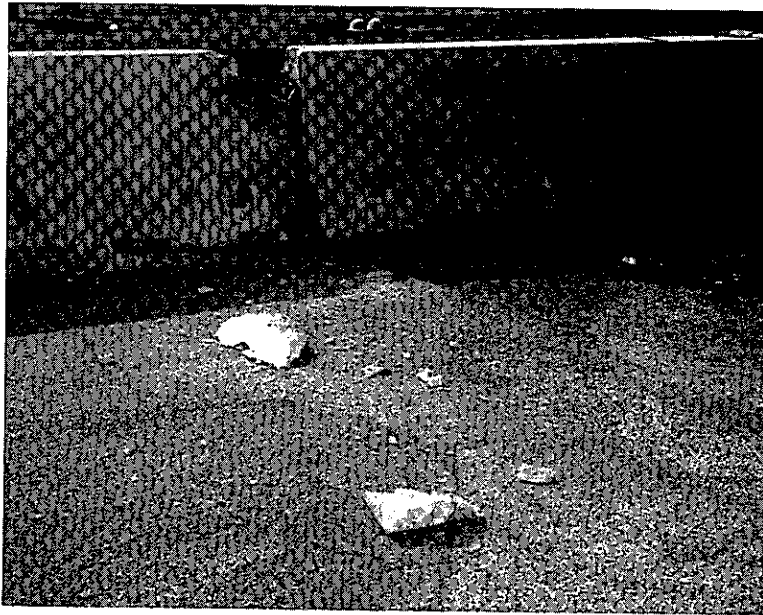
Figure 15, Concrete Spalling at Joint 6 (first joint downstream from impact) Test 292

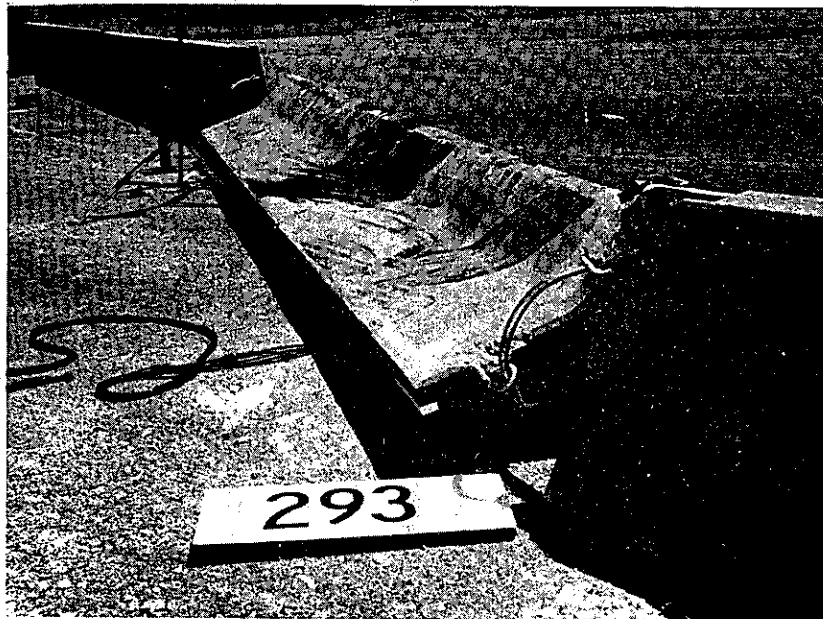
Figure 16, Bent Hinge Bars and Steel Rods at Joints 2 and 3 (first joints upstream and downstream of impact, respectively), Test 293

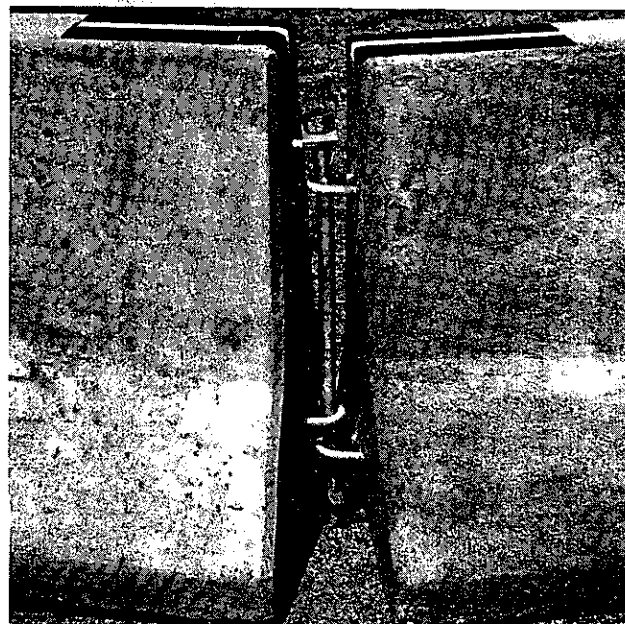
Figure 17, Bent Steel Rod at Joint 1 (second joint upstream from impact), Test 293

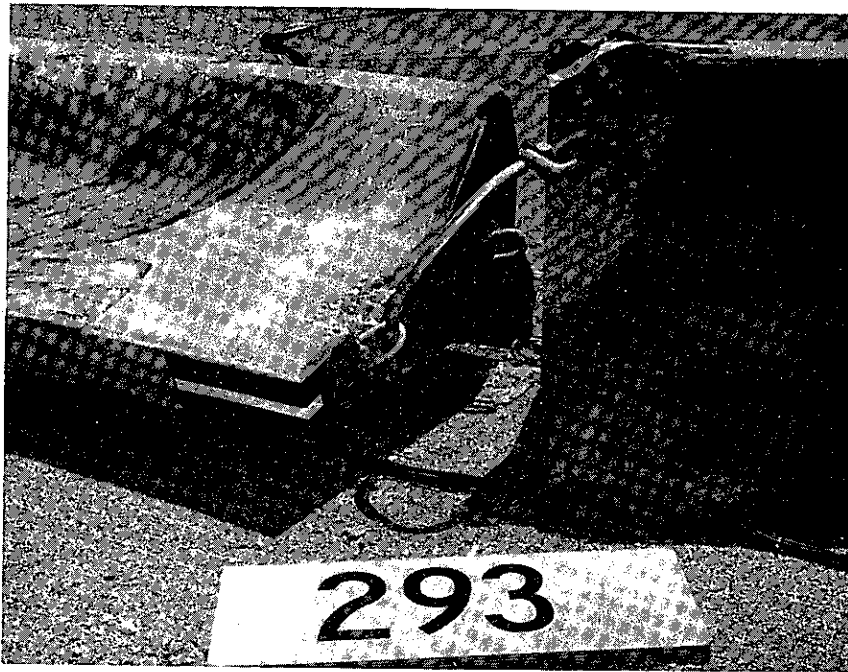
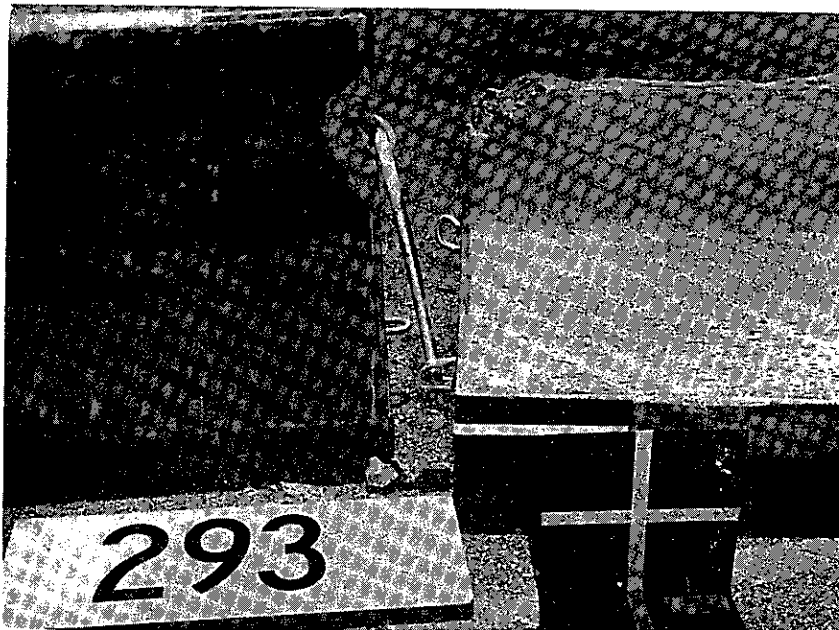
Concrete spalling also occurred at joints 2 and 3, Figure 18.

Figure 18, Concrete Spalling at Joints 2 and 3  
(first joint upstream and downstream  
of impact, respectively), Test 293.

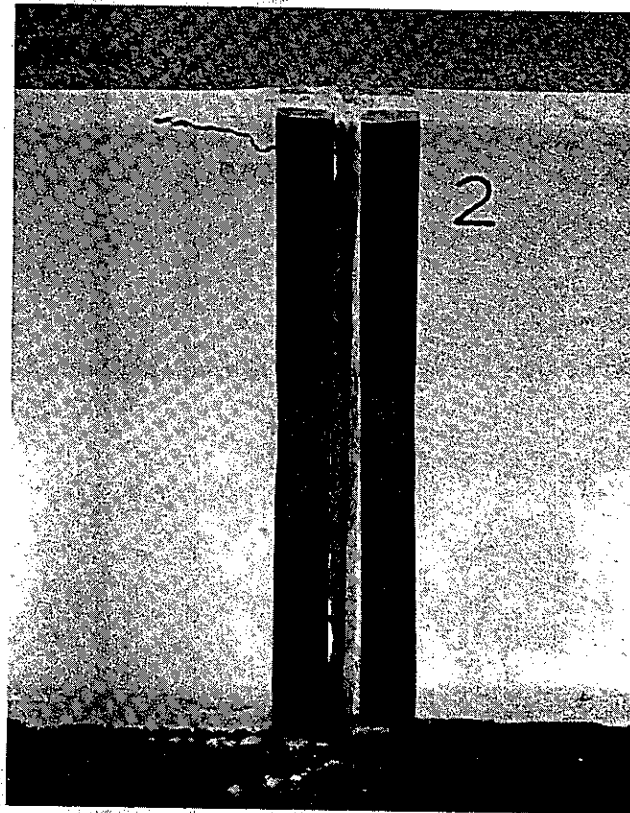
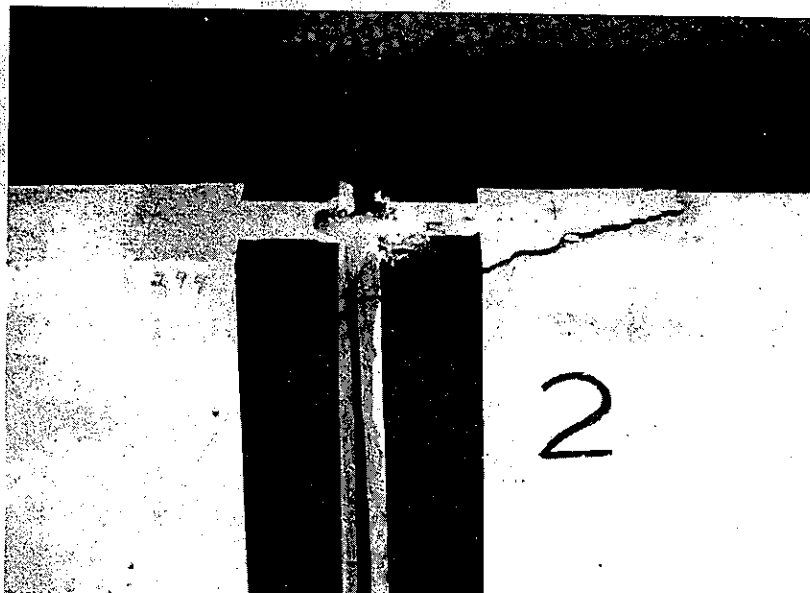
Figure 19, Concrete Spalling at Joint 2 (second joint upstream from impact), Test 294

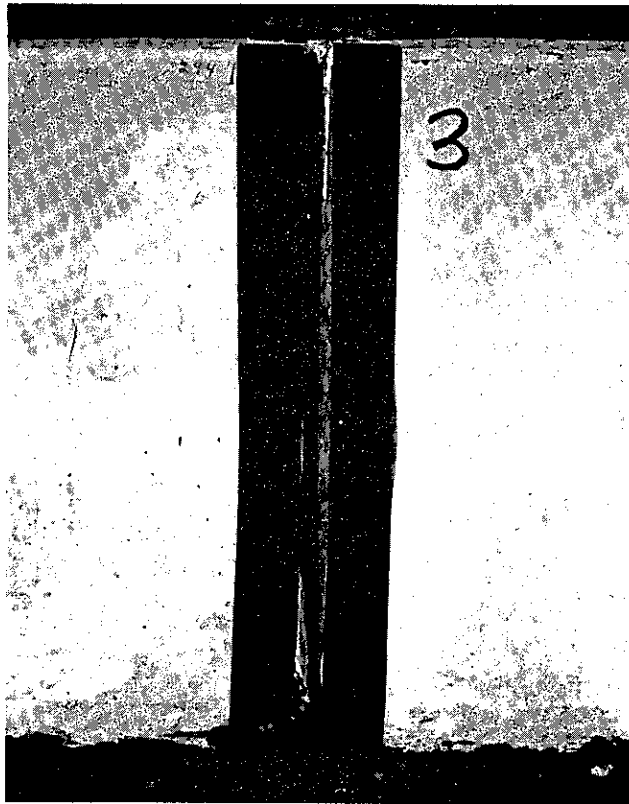
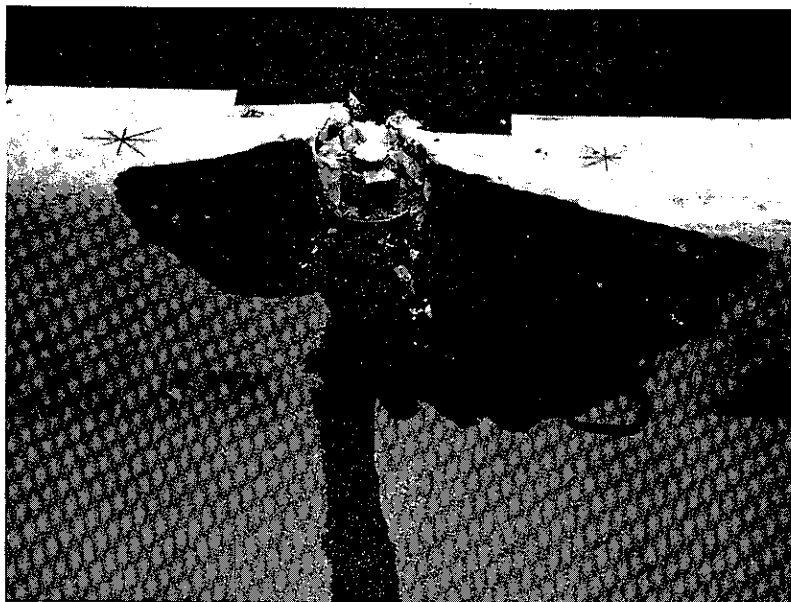
Figure 20, Concrete Spalling at Joint 3 (first joint upstream from impact), Test 294

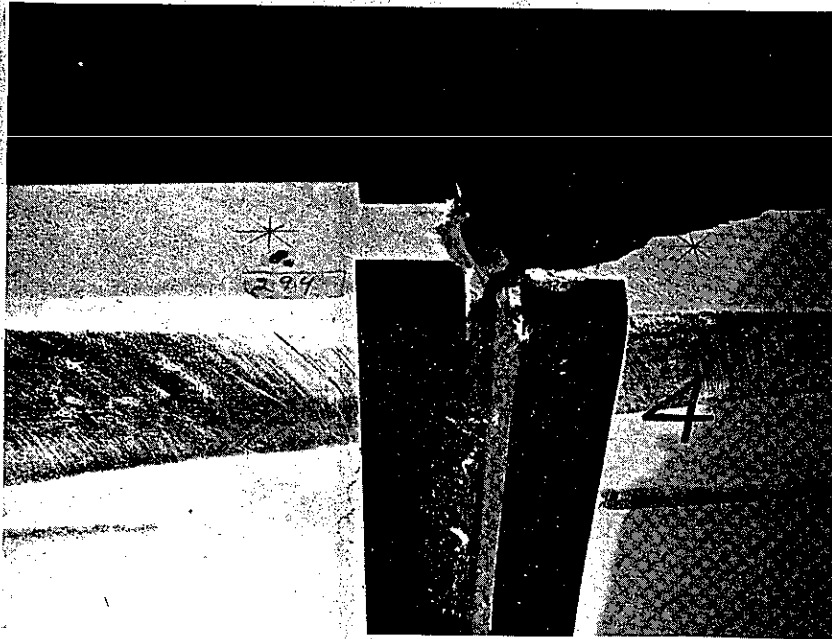
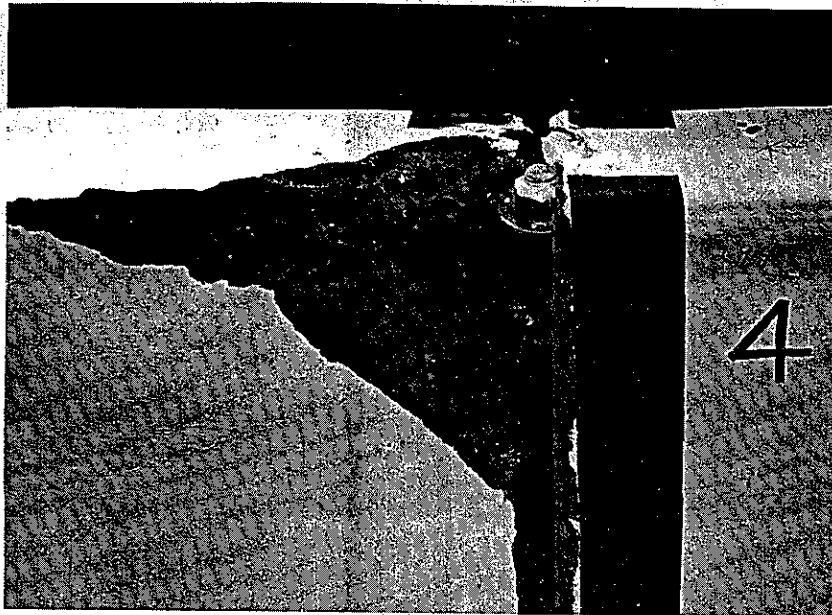
Figure 21, Concrete Spalling at Joint 4 (first joint downstream from impact), Test 294

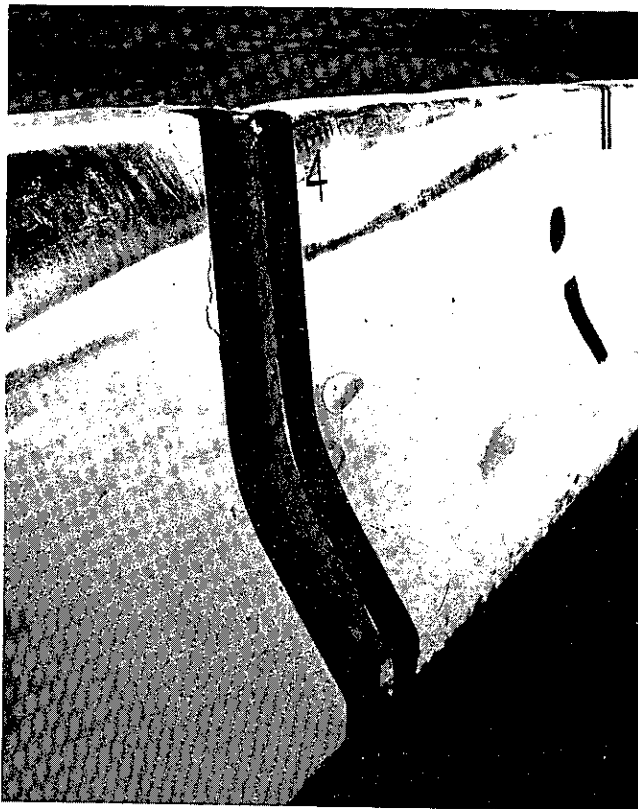
Figure 22, Barrier Scuff Marks and Scrapes, Test 294

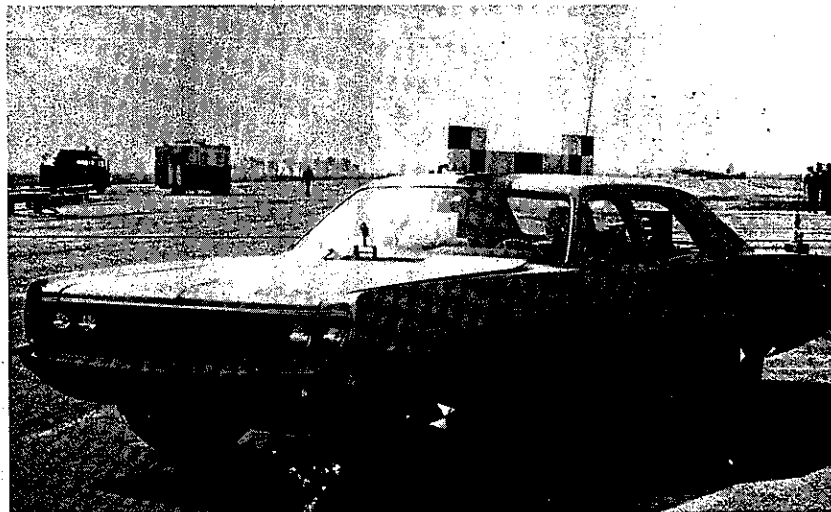
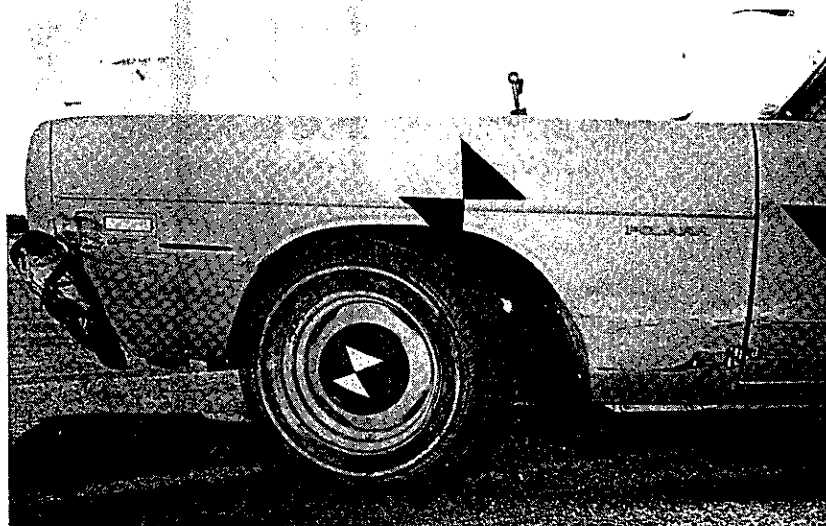
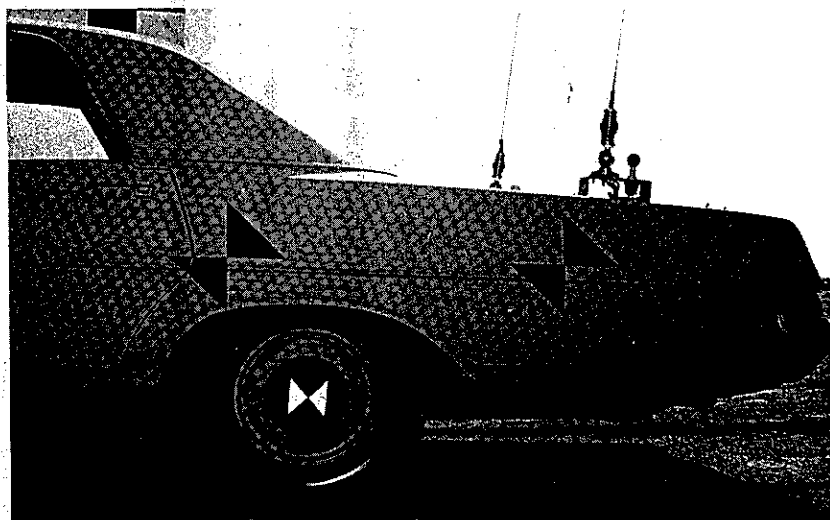
Vehicle Damage - Vehicle damage was also minimal, Figure 23. There were some minor dents and scratches on the left front and rear quarter panels of the vehicle. This same vehicle was used for a second impact test, Test 292, later the same day without being repaired. There was no intrusion of vehicle or barrier parts into the passenger compartment during impact.

Figure 23, Vehicle Damage, Test 291

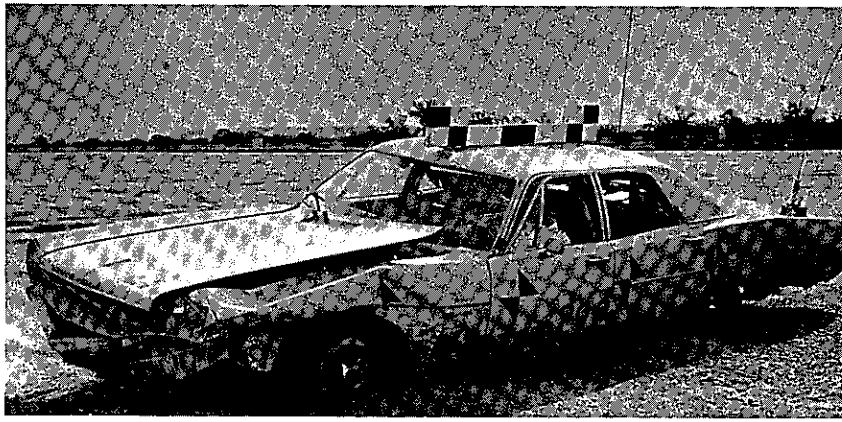
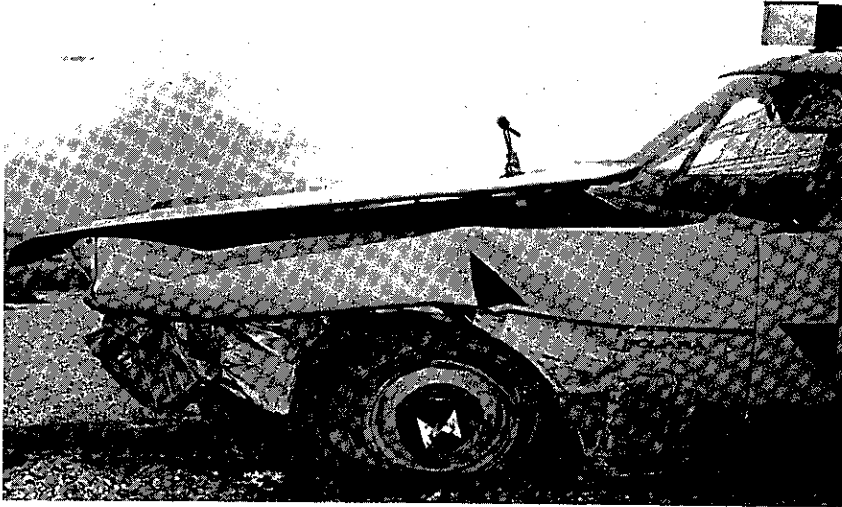
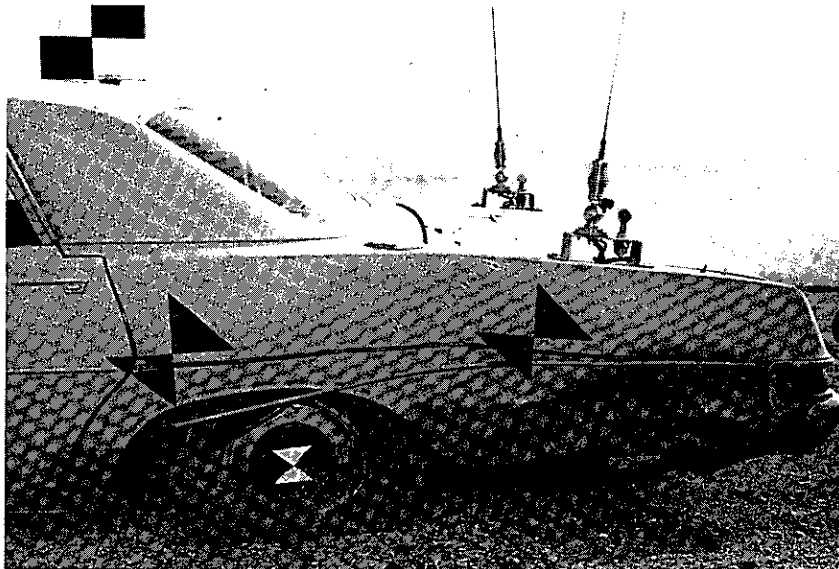
Vehicle Damage - The left side of the test vehicle suffered extensive damage during impact with the precast barrier segments, Figure 24. There was no intrusion of vehicle or barrier parts into the passenger compartment during impact.

Figure 24, Vehicle Damage, Test 292

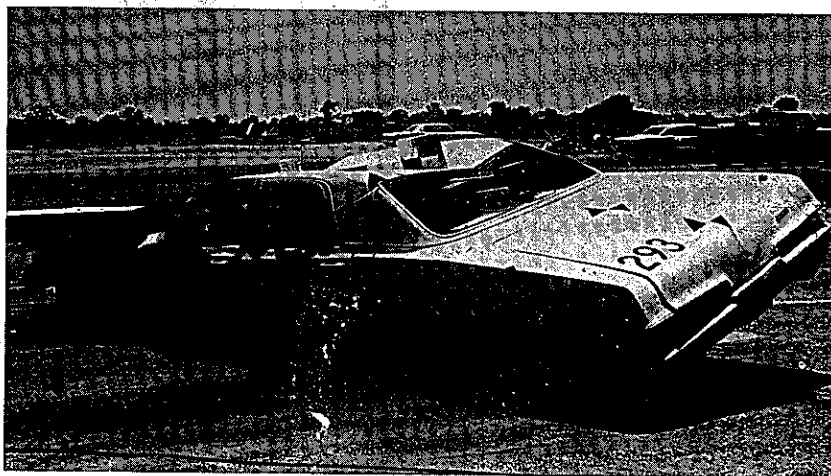
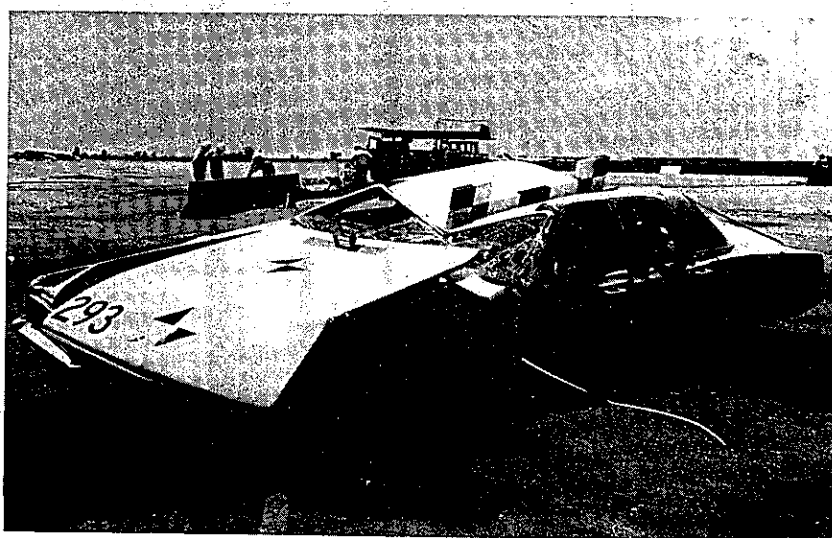
Vehicle Damage - The test vehicle was severely damaged from the barrier impact and post impact rollover, Figure 25. The engine intruded about 3 inches into the passenger compartment of the vehicle during impact.

Figure 25, Vehicle Damage, Test 293
